SUBJECT: SPECIAL SERVICE CAMPAIGN (SSC) – 60C (SAFETY RECALL)
(2004 THROUGH EARLY 2006 STEERING INTERMEDIATE SHAFT
REPLACEMENT)

Toyota will initiate a Special Service Campaign on the Steering Shaft Assembly on certain 2004 through early 2006 Model Year Prius vehicles.

**SSC 60C – 2004 Through early 2006 Prius Steering Intermediate Shaft Replacement
SAFETY RECALL NOTICE**

**2004 THROUGH EARLY 2006 MODEL YEAR PRIUS
STEERING INTERMEDIATE SHAFT REPLACEMENT**

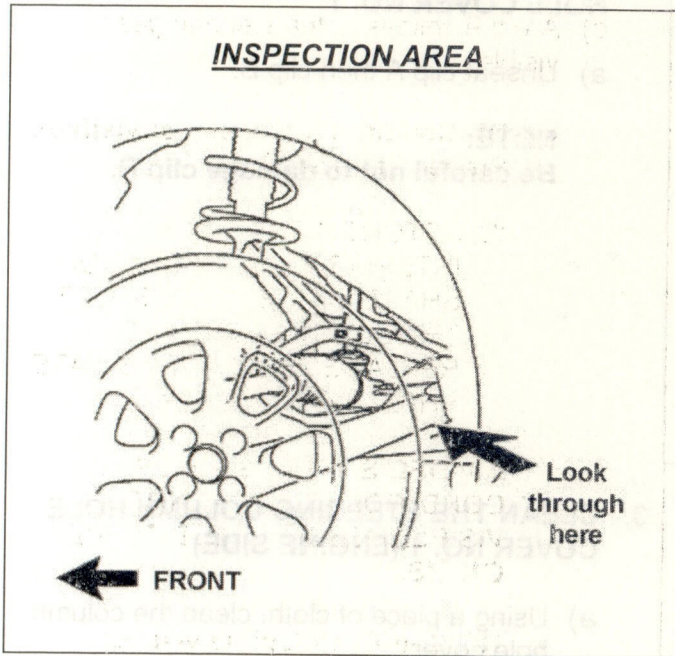
5. INSPECT THE INTERMEDIATE (EXTENSION) SHAFT NO. 1

- Turn the steering wheel to the right.
- While holding up the column hole cover, inspect the engagement point for the intermediate (extension) shaft No. 1 and steering gear by looking at it straight-on through the opening on the backside of the left front wheel well.

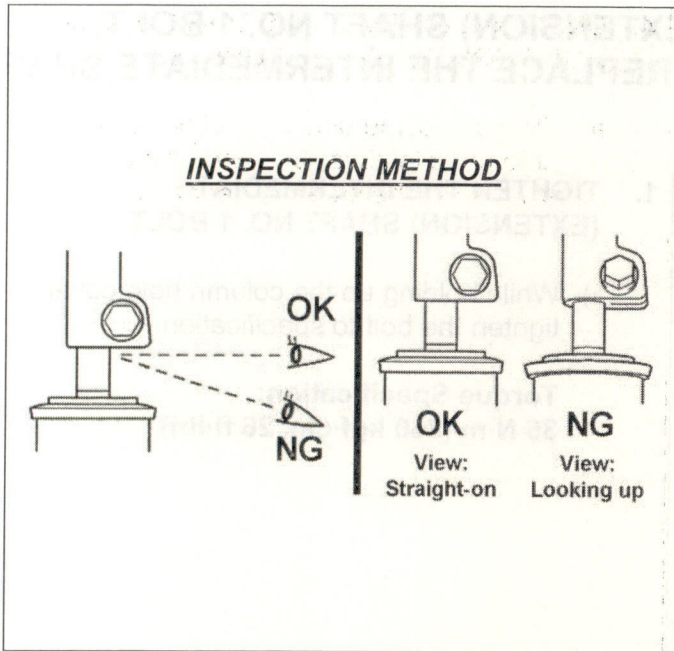
Be sure to look at the engagement point straight-on. If viewed from underneath the vehicle the ends of the splines can be seen, even when the intermediate (extension) shaft No. 1 is fully inserted onto the steering gear. This may lead to an incorrect judgment of the condition.

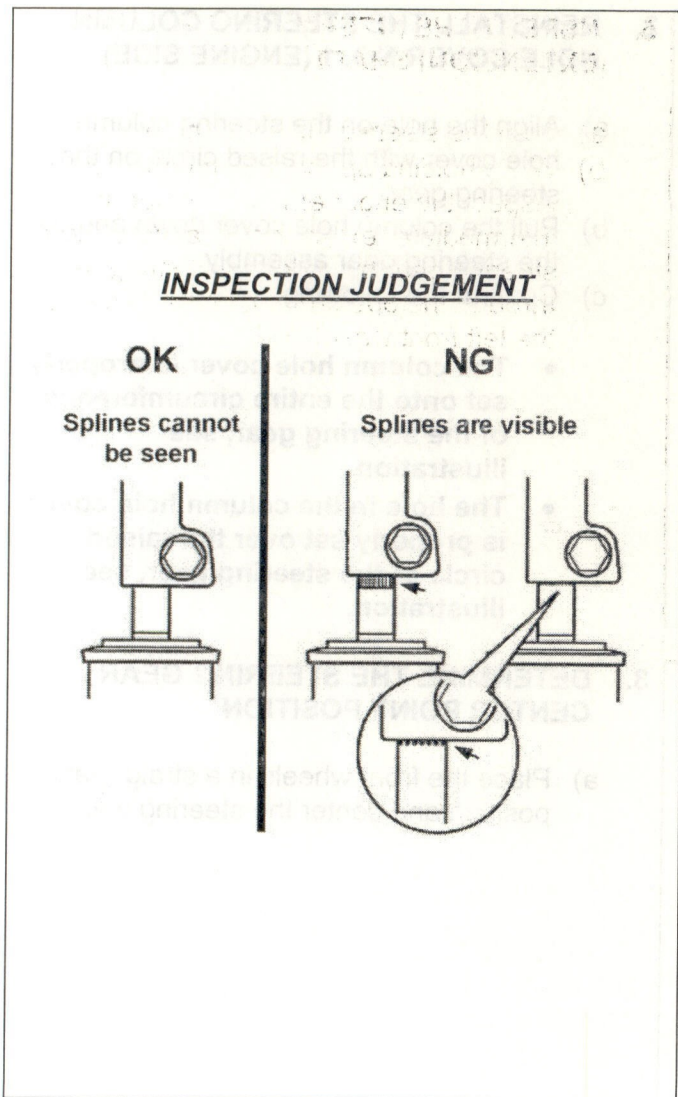
c) Are the splines of the steering gear visible?

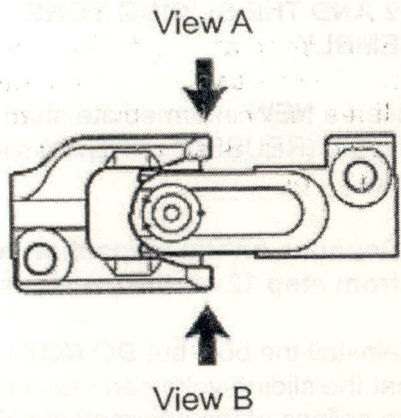
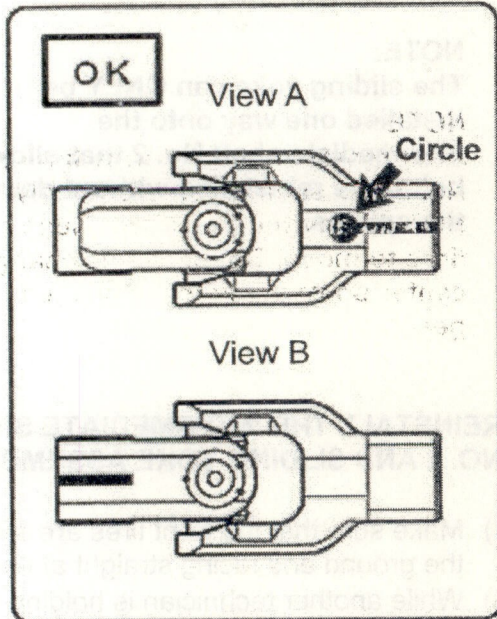
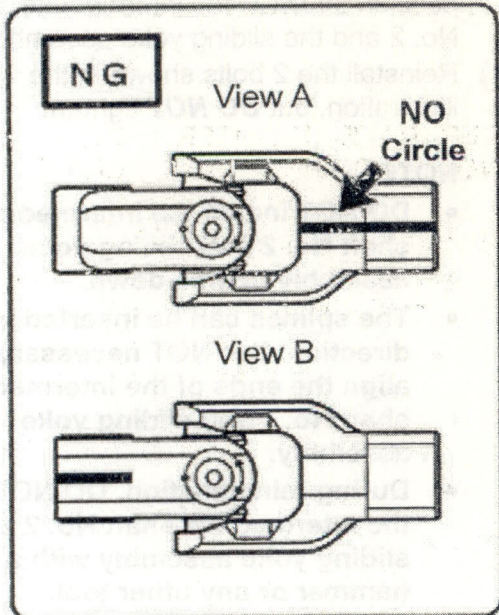
A VIDEO SHOWING AN NG SLIDING YOKE IS AVAILABLE TO VIEW ON TIS.

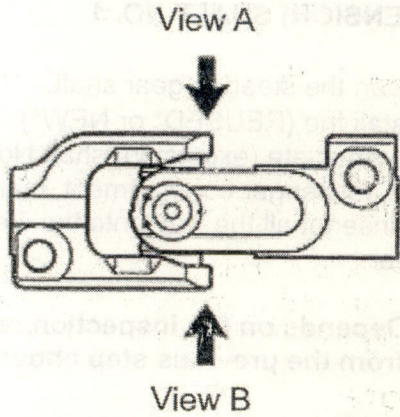
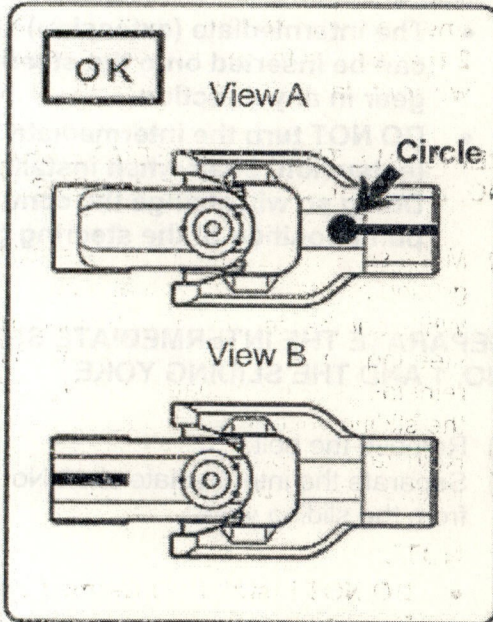
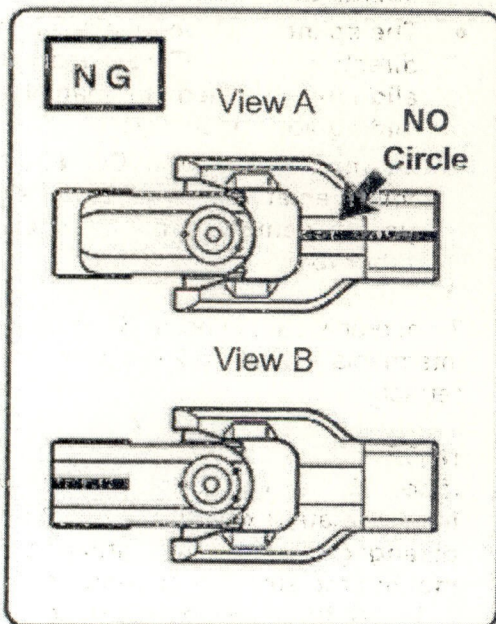
A VIDEO SHOWING AN NG SLIDING YOKE IS AVAILABLE TO VIEW ON TIS.
