SUBJECT: SPECIAL SERVICE CAMPAIGN (SSC) – 60C (SAFETY RECALL)
(2004 THROUGH EARLY 2006 STEERING INTERMEDIATE SHAFT
REPLACEMENT)

Toyota will initiate a Special Service Campaign on the Steering Shaft Assembly on certain 2004 through early 2006 Model Year Prius vehicles.

**SSC 60C – 2004 Through early 2006 Prius Steering Intermediate Shaft Replacement
SAFETY RECALL NOTICE**

**2004 THROUGH EARLY 2006 MODEL YEAR PRIUS
STEERING INTERMEDIATE SHAFT REPLACEMENT**

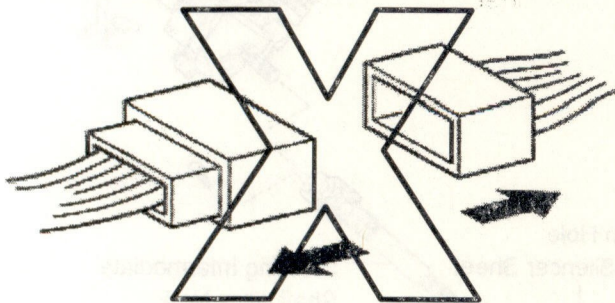
DO NOT disconnect any EPS connectors

a) Disconnecting an EPS system connector may cause a difference in steering effort between the left and the right. If steering effort is affected, a zero point calibration may be required.

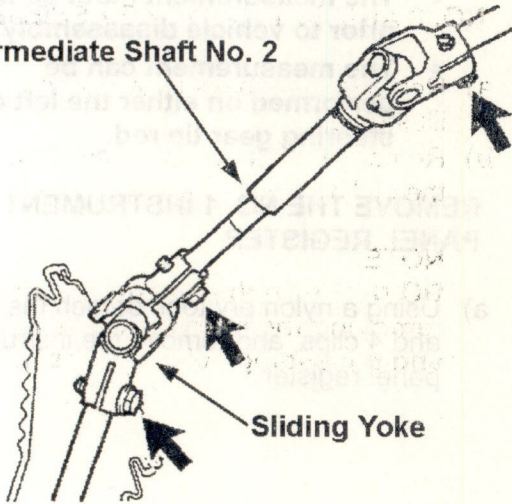
Intermediate Shaft No. 2

DO NOT remove the 3 bolts! Doing so may cause the splines to disengage, changing the center point position.

- a) Loosen the 3 bolts shown in the illustration, but **DO NOT** remove them.

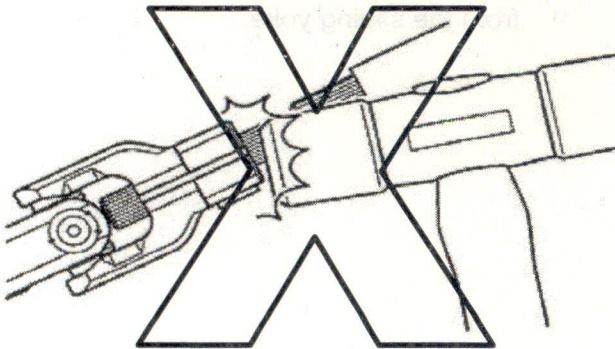
DO NOT hit the intermediate shaft no. 2 and sliding yoke assembly!

If you are having difficulty removing the intermediate shaft No. 2 and sliding yoke assembly from their splines, **DO NOT** hit them with a hammer or any other tool. Doing so may damage the shock absorbing mechanism or the joints of the steering system.
